## Inspection Report

**Client:** Lynne Jones **Date:** 6-9-15 **Doc. #** 16220

**Inspection Location:** 5034 17th Ave NE Seattle Wa **Building Type:** Three story

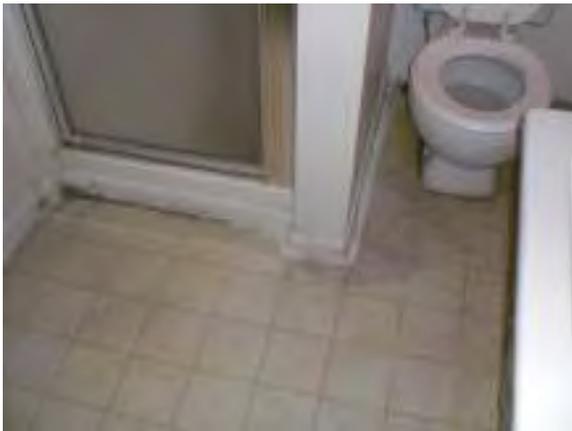
There is water damage to the floor in the upper south ¾ bathroom.

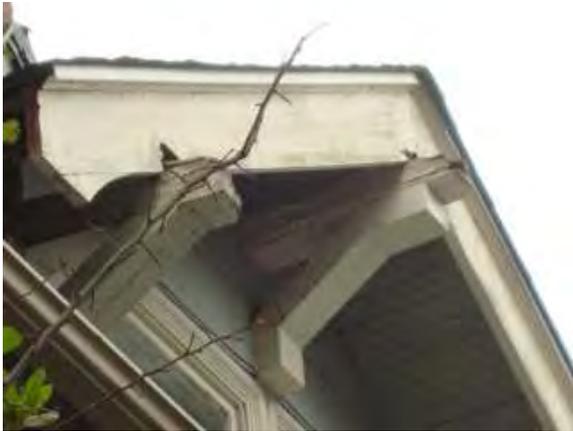
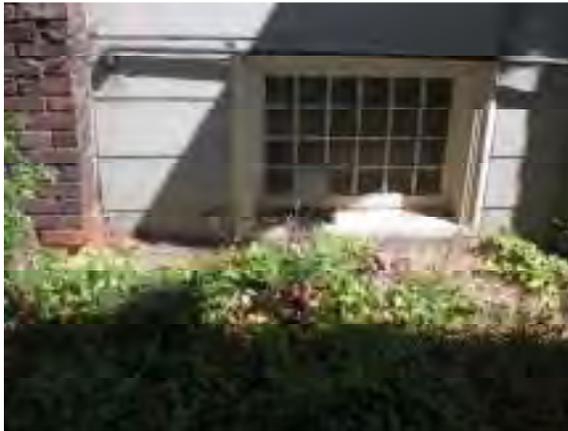
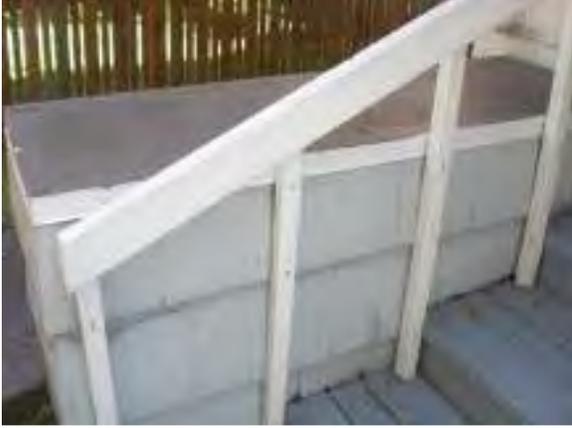
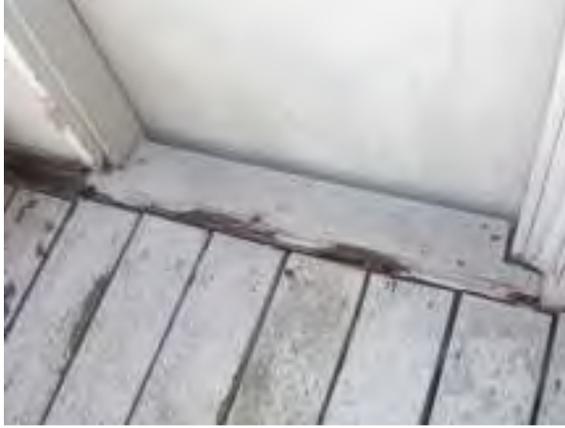
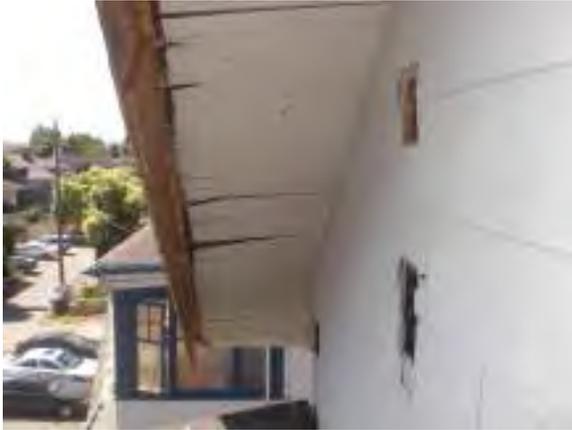
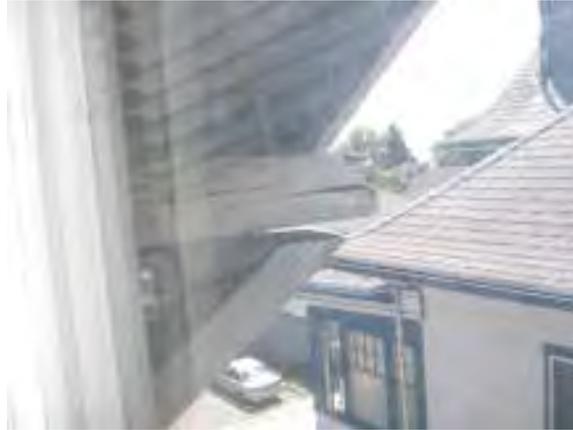
Most of the siding is in good condition. Minor deterioration is occurring to the siding next to the front stairs. A small amount of siding and trim boards are missing at a few points around the building. Damage materials should be replaced. Siding and trim boards should be installed as needed to ensure that the entire exterior remains fully waterproof.

Some of the cedar shingles next to the front porch stairs are rotting. All damaged wood should be removed and replaced with new wood. The plywood rail wall caps have not been installed in a fully waterproof manner.

There is earth to wood contact on both the south side and at the northwest corner. All earth should ideally be kept at least 6" below siding, trim and any other wood members unless the wood is treated wood rated for earth to wood contact. All damaged wood should be removed and replaced with new wood.

The knee braces and some of the framing have been removed from the upper east side edge of the roof system. These components need to be re-installed now. The existing fascia board here needs to be painted.

Rot is occurring to some of the fascia boards and knee braces at the corners and side edges of the roof. This is most noticeable on the south side of the building. Rot is also occurring to the upper north exterior door threshold. There is minor deterioration occurring to some of the lower soffit boards at the southeast corner. All damaged materials should be removed and replaced. Some paint peeling is occurring and painting should be done as needed.

The back north porch door and the lower east door skins are delaminating and will need to be replaced.

The fire escape stairs system along the north side of the building that leads down to the alley is basically stable but does sway and installing additional cross bracing is recommended. The upper older section has settled and may need to be repaired in the future. The upper rail is loose and needs to be stabilized. Some nail heads in the porch boards need to be set.

In general, all damaged materials should be removed and replaced, all intersections should be sealed with caulk and/or flashing as needed and the entire exterior should be kept weather-proof.

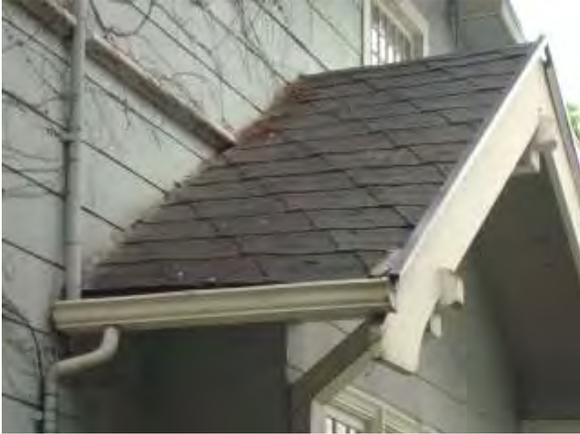
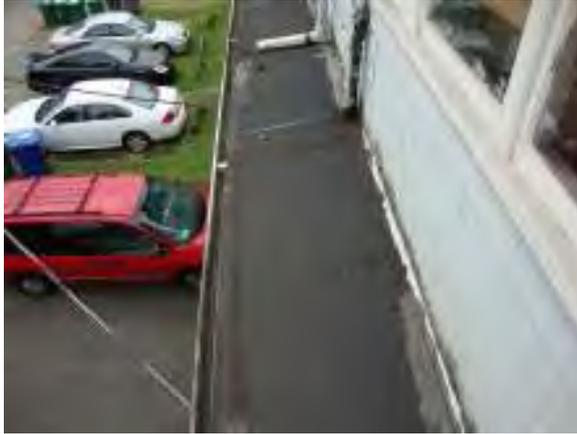
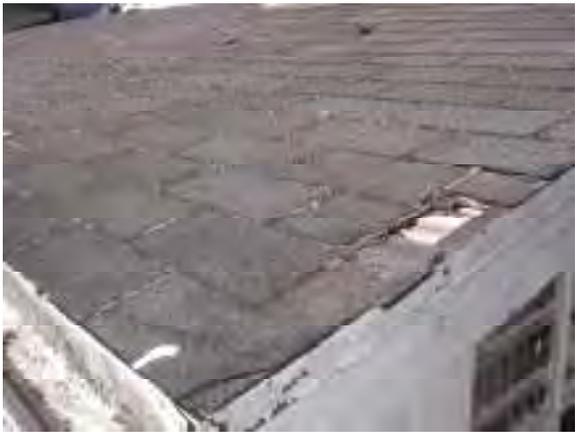
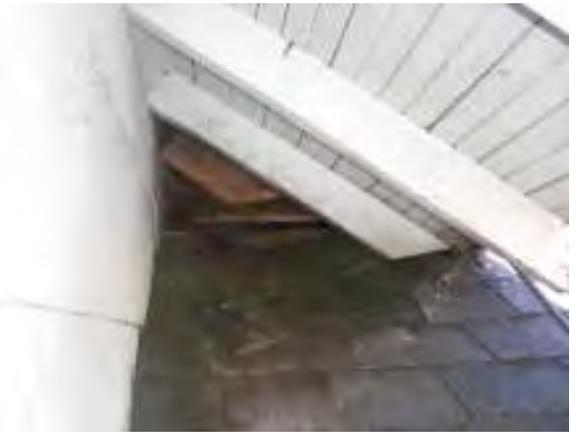
The roofing material on the lower side roof sections and on the back of the builder is older and noticeable deterioration is occurring. Some shingles are missing. Normal standards would dictate that re-roofing be done here now or in the near future.

The roof edges do not extend far enough into the gutters at some sections and flashing should be installed here to ensure that all water drains fully from the roof into the gutters.

There is no counter flashing where the front porch roofing material intersects with the siding. At a minimum, sealant must be maintained here.

There is an opening in the roof system underneath the upper north roof edge that should be sealed to keep animals out.

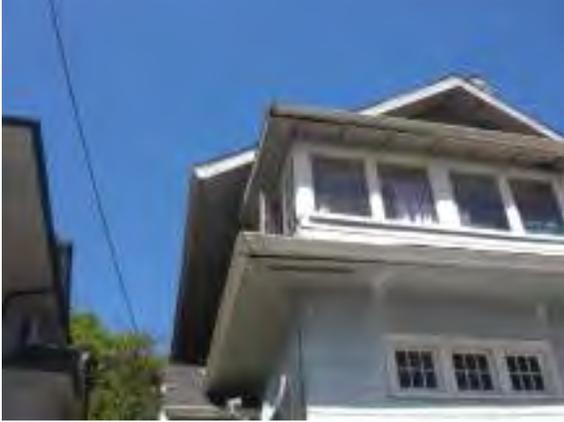
The gutter at the lower southeast corner of the building is damaged and will need some repair/replacement.

The upper southeast gutter is leaking noticeably. Some other gutter joints are also leaking.

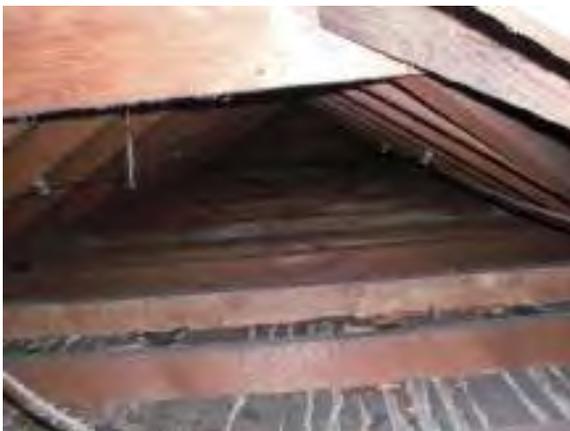
There is no insulation in any of the attic spaces. All attic spaces should be fully insulated.

There are no roof vents. Roof vents are essential to ensure that excessive heat and humidity does not build up in the attic space which can diminish roof life. The formula for proper attic space venting is 1 sq. foot of venting for every 300 sq. feet of attic space providing the vent is in the upper area of the space to be vented and there is cross ventilation. If these conditions are not met, the formula changes to 1 sq. foot of venting per 150 sq. feet of attic space.

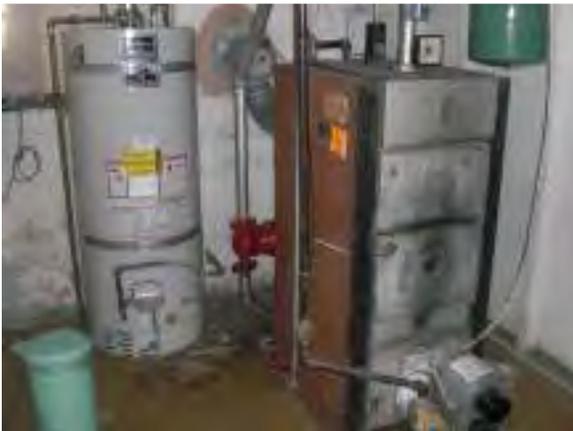
A boiler is located in the basement that circulates hot water to the individual radiators that are located inside the majority of the interior rooms. This boiler is quite old and the life expectancy is unknown. The boiler was operated for a short time during the inspection it did not appear to produce much hot water. At a minimum, servicing/repair of this boiler is needed now. Replacement could be needed any time. When servicing/repair is done, it should be confirmed at hot water flows fully to all radiators throughout the interior of the building.

There is asbestos material on or around the heating pipes. For a definitive explanation of asbestos related issues, contact the EPA or a qualified asbestos abatement expert.

The basement unit apartment has a separate gas-fired heater. Servicing of this heater is needed now.

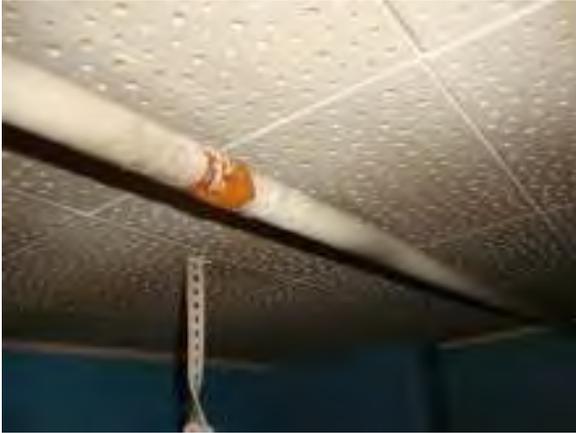
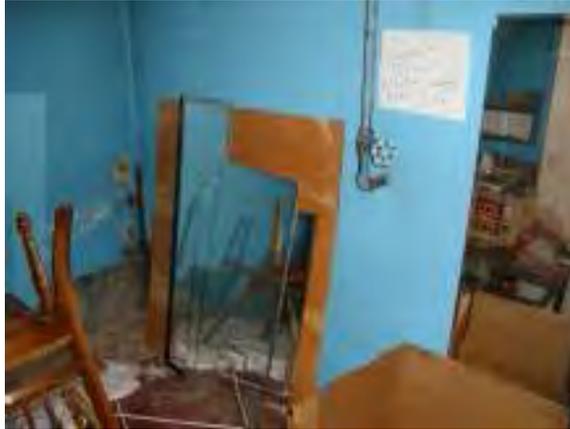
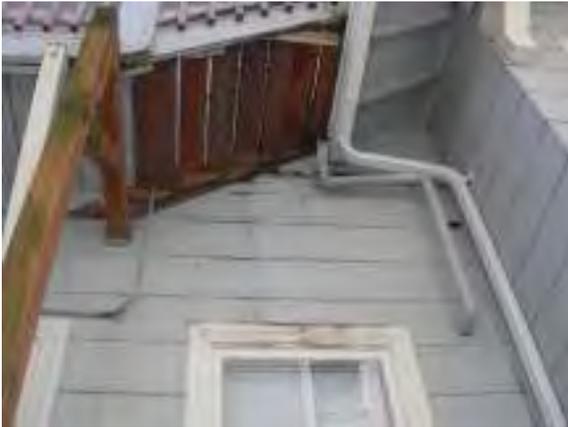
The majority of this building is plumbed with galvanized water lines. It is common for galvanized piping to corrode over time and some sections may need replacing in the future. Some corrosion was observed. In addition, the water volume is low and drops in multiple fixtures are operated. This water volume is significantly lower in some sections of the building. The only way to correct this is to replace older water lines.

There are plumbing vents on north side of the building that needs to be secured and should vent above the roof line.

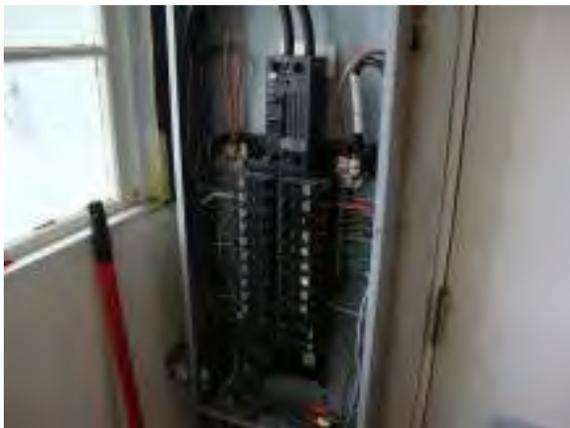
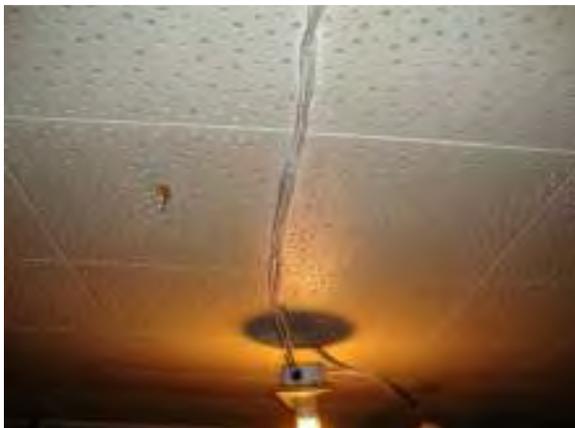
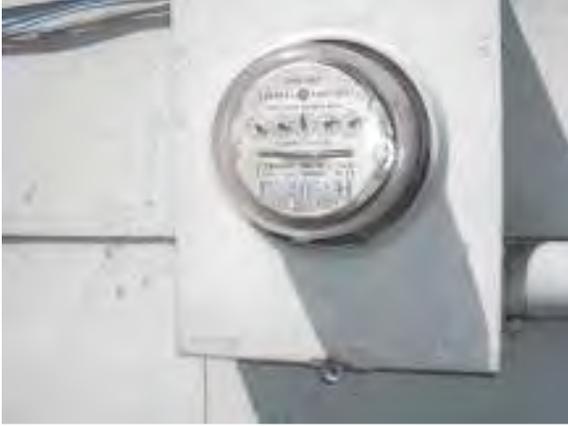
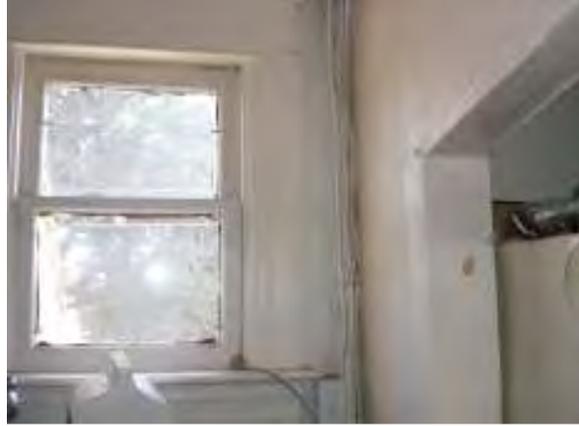
A newer 200 amp circuit breaker panel has recently been installed is in good condition. However, the meter seal is cut and most likely this panel was installed without permits and inspections. It is recommended that the permitting and inspection process be completed.

The majority of the wiring throughout the interior of the building has not been upgraded. In addition, there are a number of significant potential minor electrical safety hazards which mostly include the use of exposed wiring and extension cord wiring. Wiring not in the ceiling or wall space should be in conduit. No permanently wired extension cord applications should be used anywhere in the building. All extension cord wiring should be removed. If replacement wiring is needed, new wiring should be installed to current code.

Most of the 3-prong receptacles are not grounded. This generally occurs when older 2-wire, 2-prong receptacles are replaced with newer 3-prong receptacles, which gives the illusion that they are grounded when they are not. Recommended upgrading would include installing 3 prong grounded receptacles in all bathrooms, kitchens, basements, garages and all exterior locations. All of these 3 prong receptacles should be protected by a ground fault circuit interrupter.

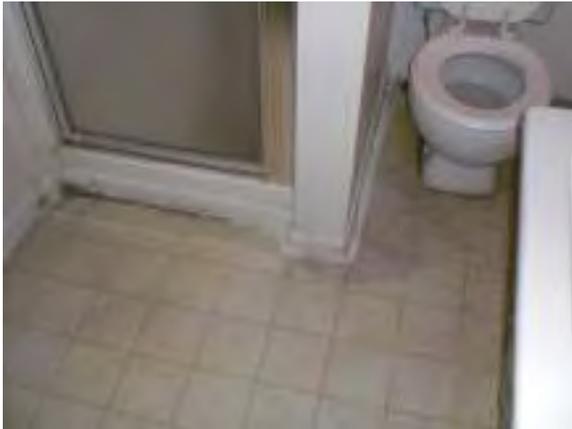
There is water damage to the floor in the upper south ¾ bathroom.
