Metcalfe Building Consultants Inc

Inspection Report

Client: Michael Ness Date: 2-24-16 Doc. # 16462

Inspection Location: 3115 Franklin Ave. E. Seattle Washington Building Type: Two story

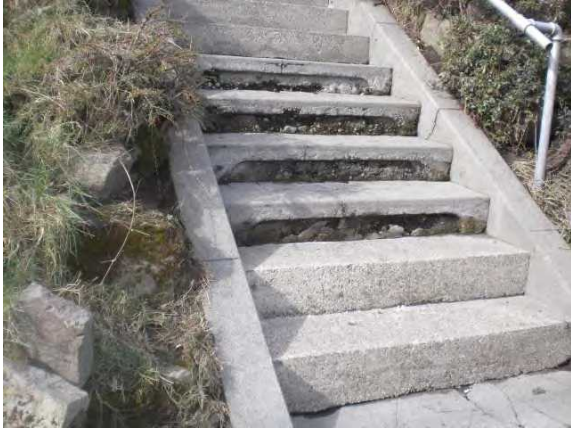
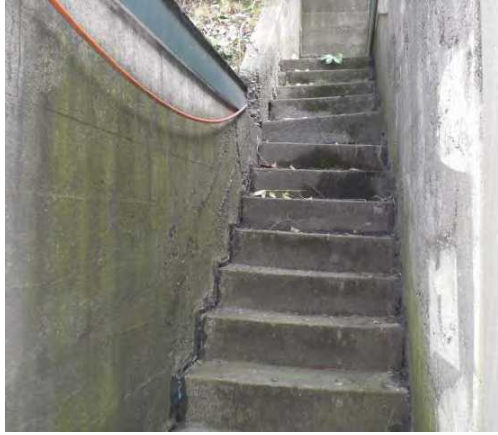
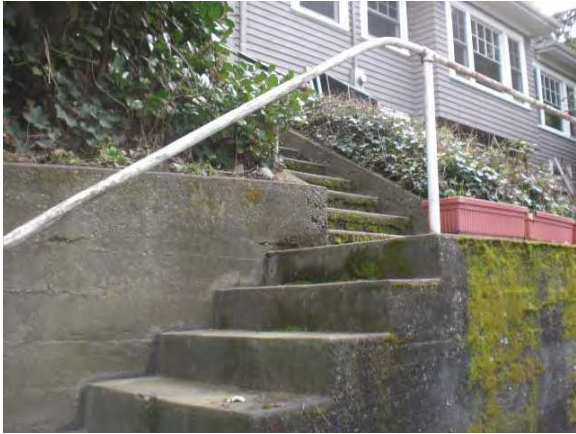
Settlement has occurred to the stairs on both the front and back of the property. This is common to find for a building of this age. The settlement does pose minor tripping hazards. Installing full handrails is recommended. Current code requires all decks, stairs and porches to have railings at least 30" high and vertical or horizontal rail members no farther apart than 4" for safety purposes.

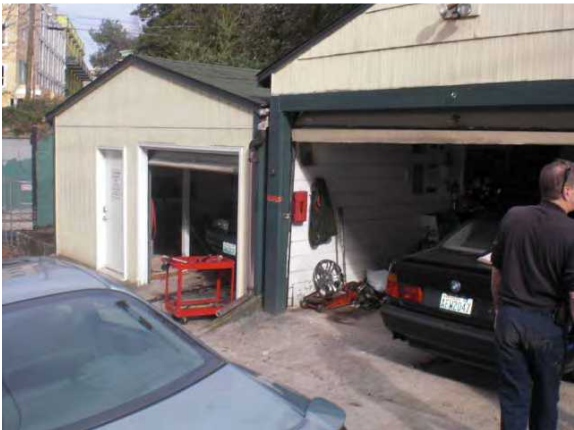
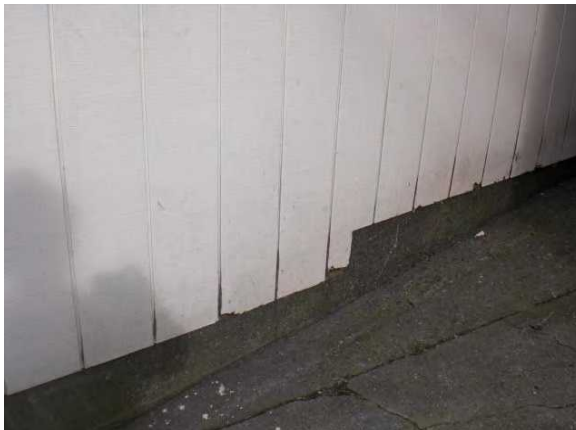
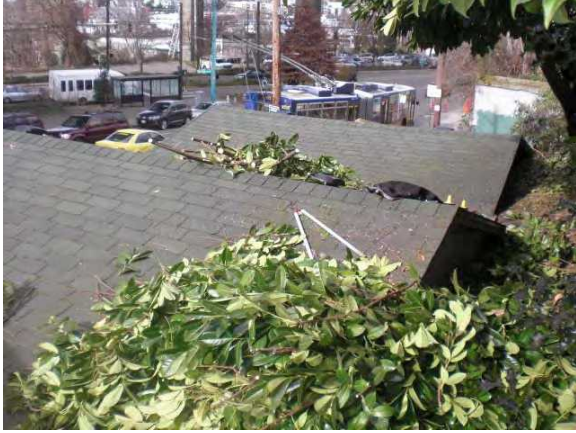
This garage does not have a standard power supply and relies on an extension cord that is connected to an outlet on the back of the main building.

Some delamination is occurring to the plywood siding. All damaged wood should be removed and replaced with new wood. Plywood siding should be kept well painted or stained at all times since it is a manufactured siding and will delaminate easily if not protected.

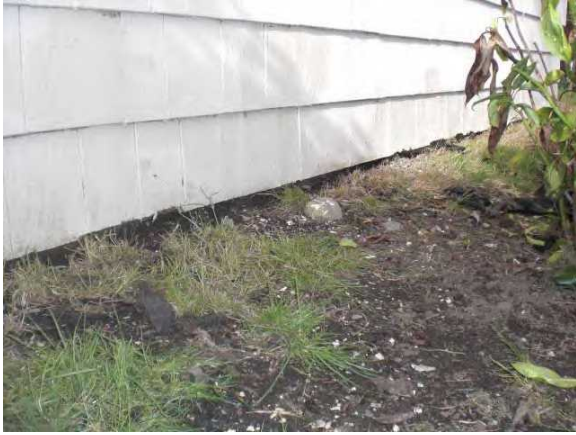
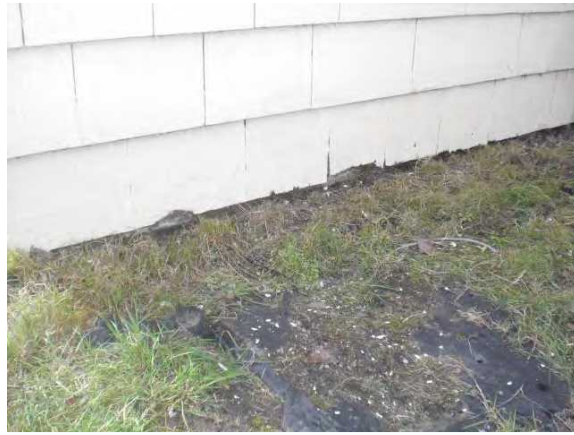
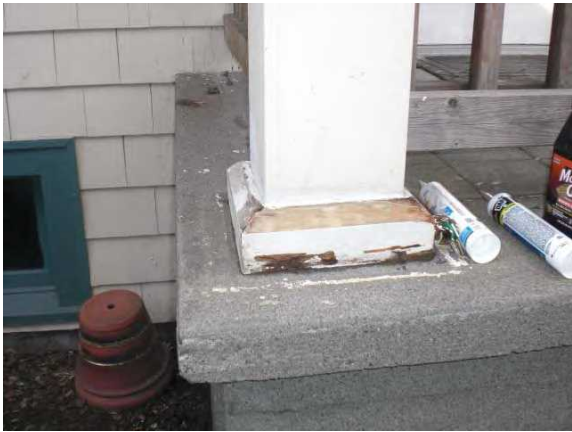
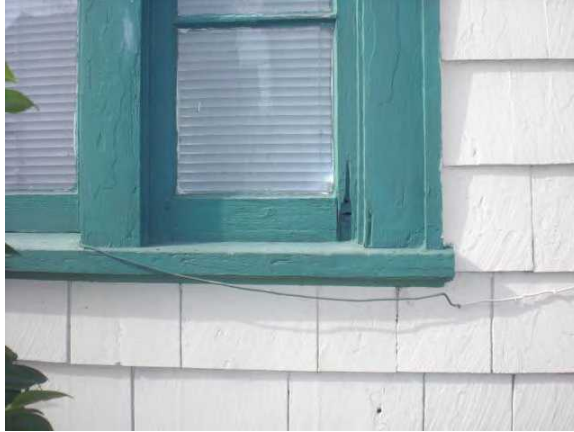
There has been previous earth to wood contact around the front northeast corner of the building. Some deterioration is occurring here. All earth should be kept at least 6" below siding, trim and any other wood members unless the wood is treated wood rated for earth to wood contact. All damaged wood should be removed and replaced with new wood.

Deterioration is occurring to the north porch system including to the handrails and plywood siding. Damaged materials should be completely removed and replaced. The exterior door here is delaminating and should be kept well painted at a minimum.

Deterioration is also occurring to the lower trim boards around the front porch support columns. All damaged wood should be removed and replaced with new wood.

The trim around the basement unit exterior door has been partially replaced. There is a passive drain here at the bottom of the stairs that most likely backs up which could cause additional deterioration to occur to the trim boards here.

In general, all damaged materials should be removed and replaced, all intersections should be sealed with caulk and/or flashing as needed and the entire exterior should be kept weather-proof.

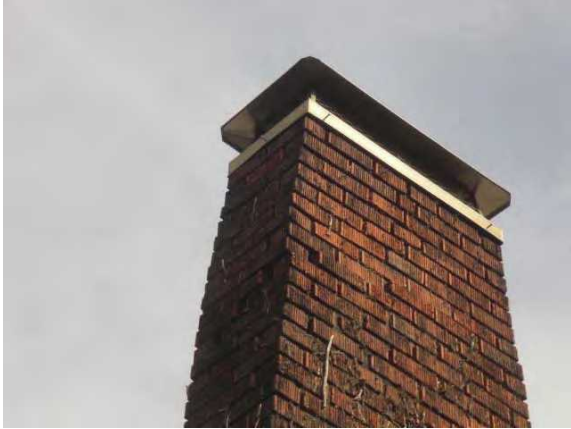
The general condition of the majority of the chimney is good.
There are loose bricks and loose mortar at the top of the chimney. Partial rebuilding and re-mortaring is needed at this time.

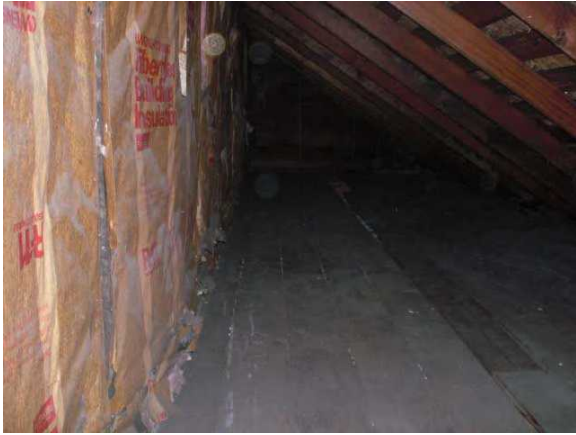
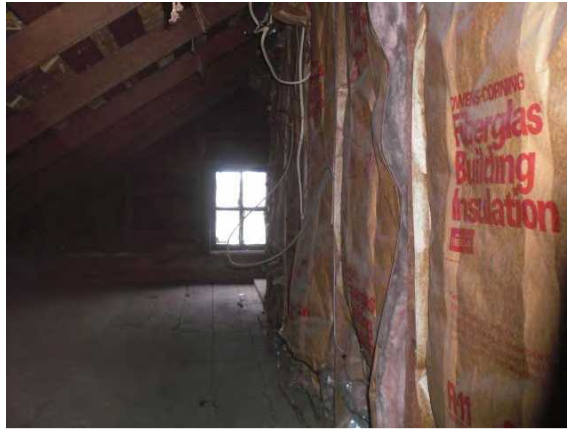
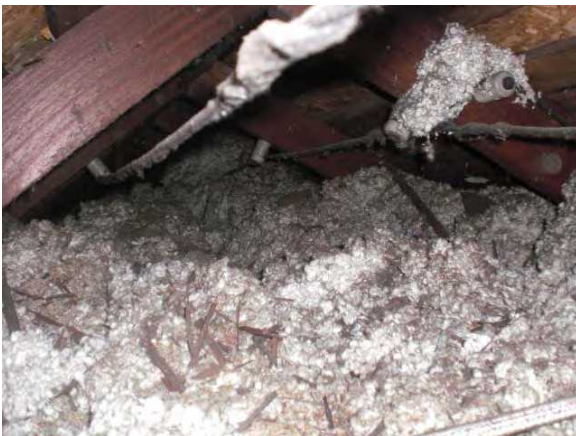
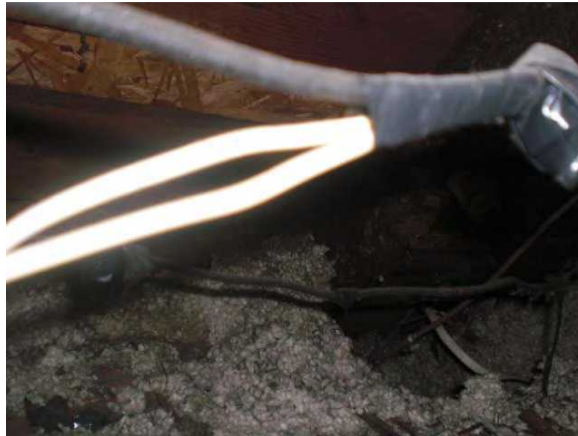
The amount of insulation in the attic spaces is considered quite minimal and installing additional insulation is recommended.

There are a number of exposed electrical applications, including wire splices that should be repaired now. One of the heating ducts in the side attic space is damaged. All heating ducts should be fully insulated.

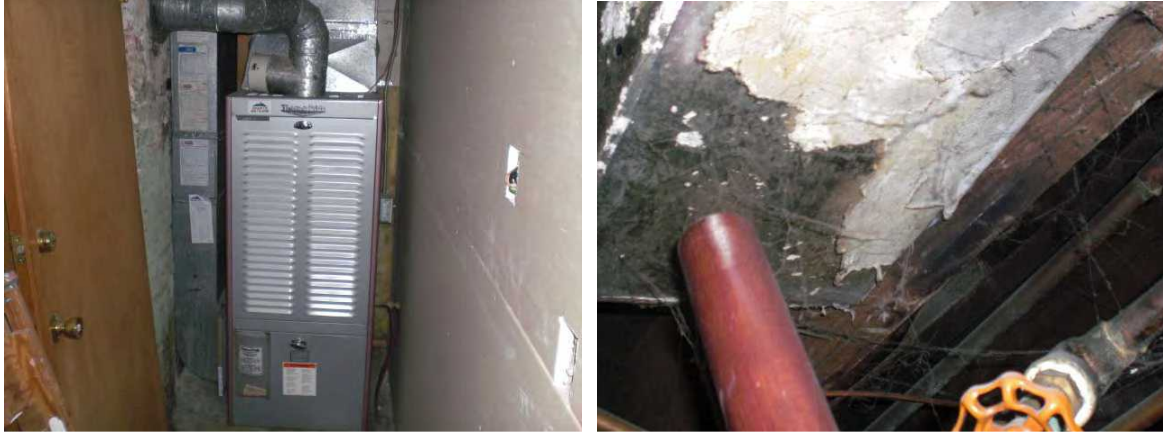
There is asbestos material on or around the heating ducts. For a definitive explanation of asbestos related issues, contact the EPA or a qualified asbestos abatement expert.

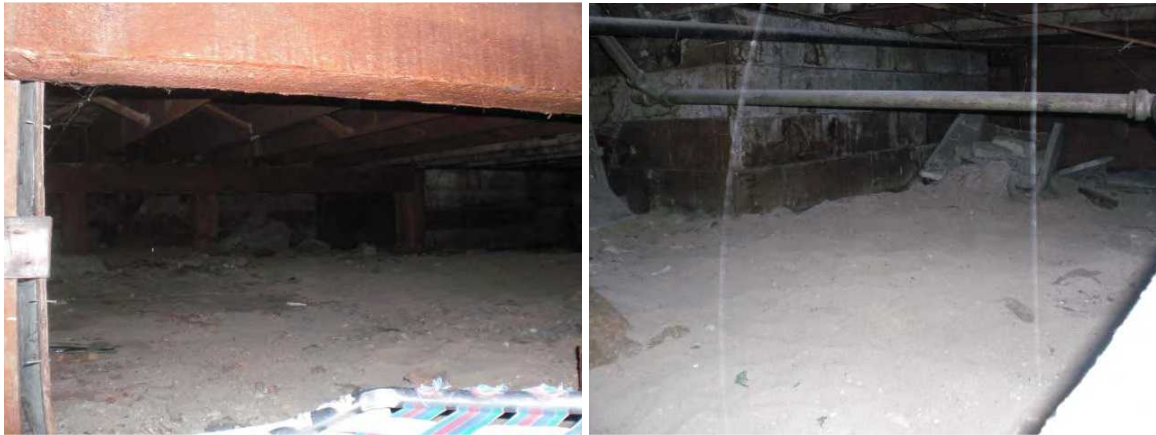
There is earth to wood contact in the crawl space area. No earth should contact wood of any type unless the wood is treated and rated for earth to wood contact. All damaged materials should be removed and replaced.
