# Metcalf Building Consultants Inc

## Inspection Report

**Client:** ACADEMY HOUSING, LLC / Mr. Peter Hong **Date:** 6-17-16 **Doc. #** 16602

**Inspection Location:** 4528 20th Ave NE Seattle Wa **Building Type:** Three story

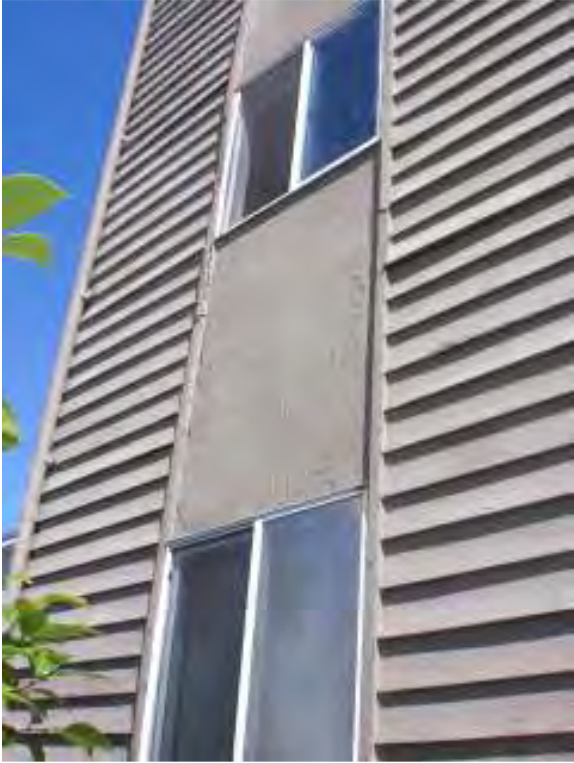
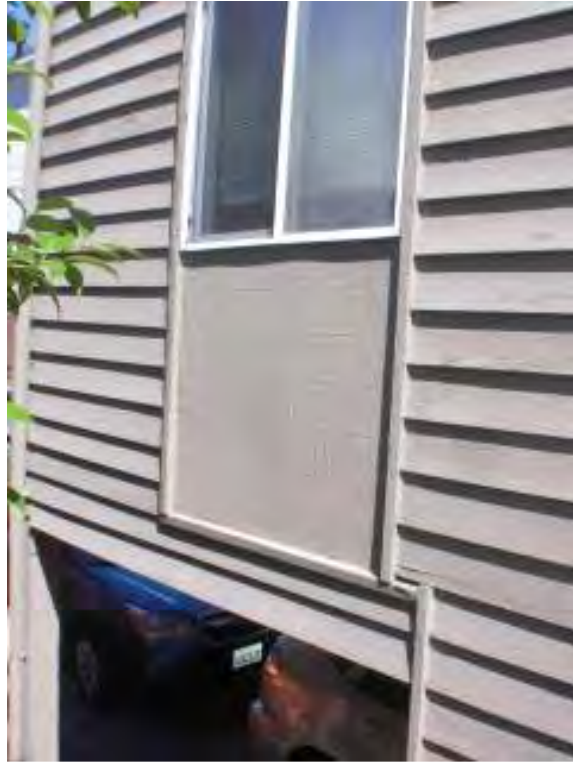
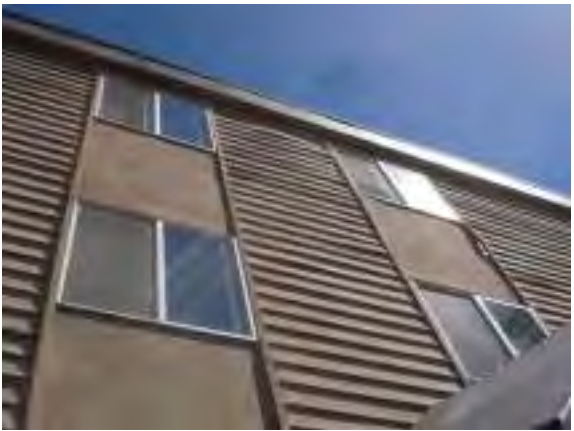
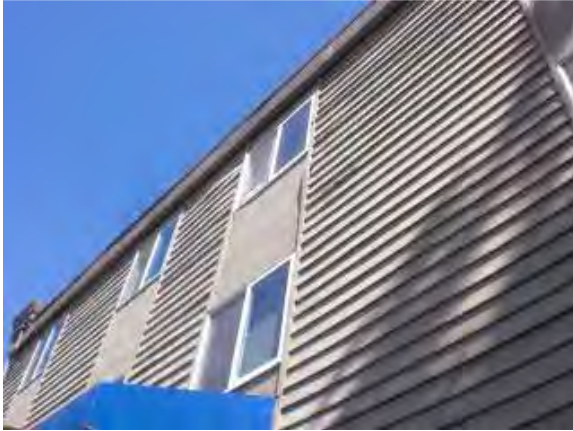
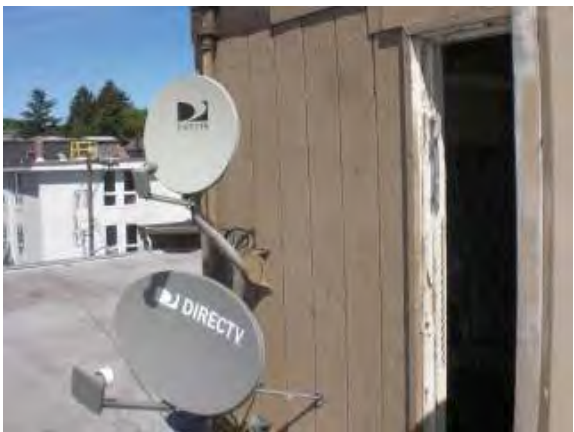
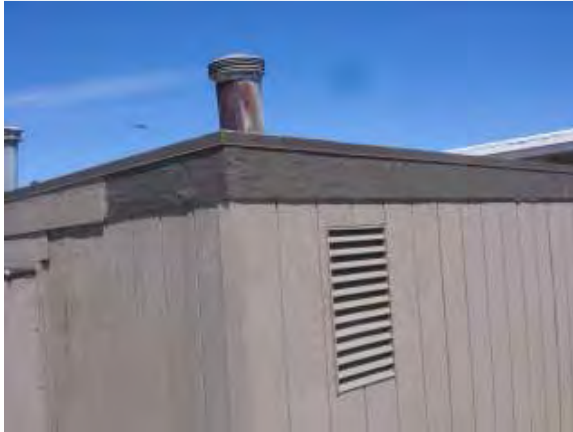
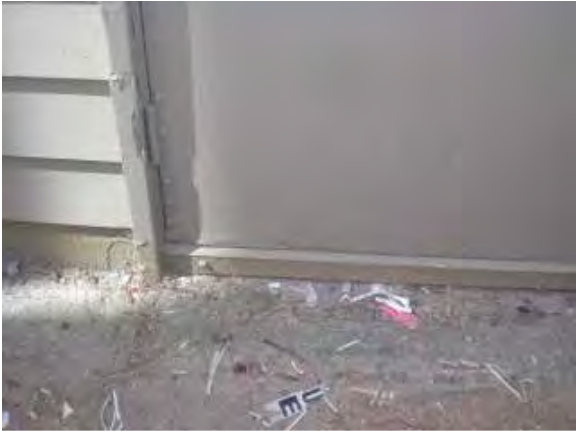
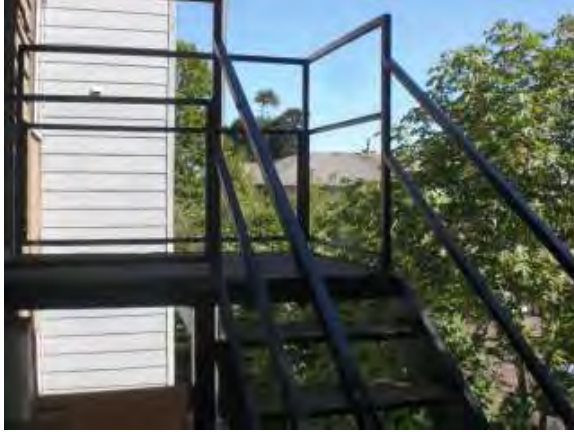
However, the siding and trim boards on the south side of the building are deteriorating. This deterioration is also evident to the siding and trim boards around the top enclosure above the roof line. Paint peeling is also occurring.

The back metal handrails are in generally good condition. However, the rail system is not childproof. Current code requires all decks, stairs and porches to have railings at least 30" high and vertical or horizontal rail members no farther apart than 4" for safety purposes. The metal handrails will need to be painted periodically with a rust inhibiting paint.

Minor deterioration is occurring to some of the exterior doors. Damaged materials should be removed and replaced.

At this time, all damaged siding and trim boards at all points around the building should be completely removed and replaced. As maintenance, all siding should be kept securely nailed to the building and all siding/trim intersections should be kept well sealed with caulk. Re-painting should be done as needed.

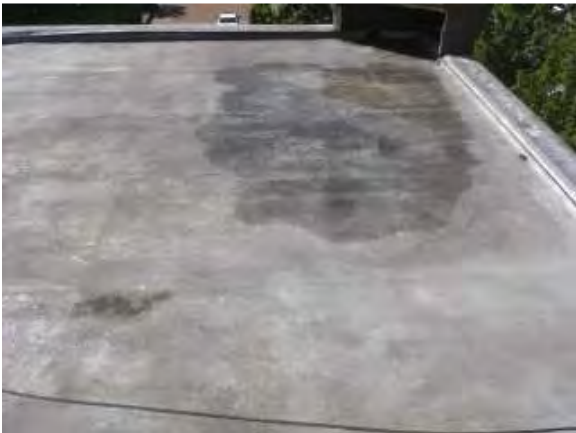
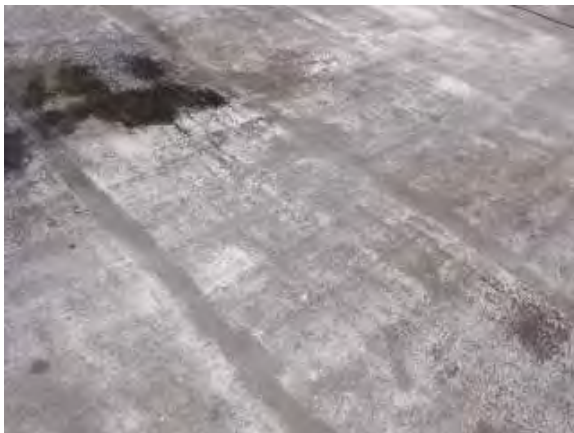
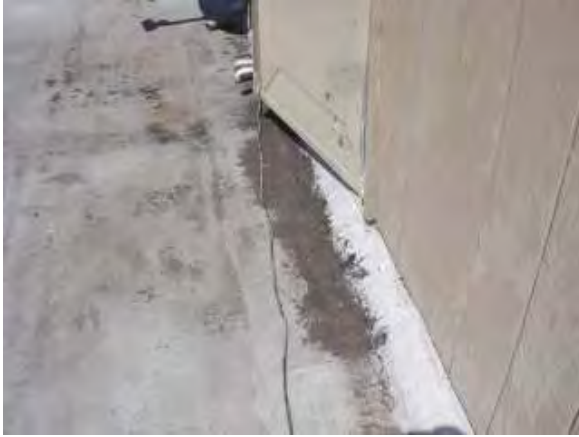
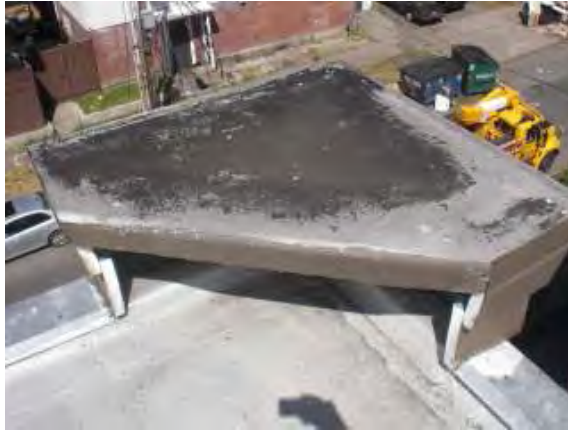
This building has a standard porch down roofing system. This roofing system is older with noticeable deterioration occurring. The most significant deterioration is occurring next to the access door.

There would appear to be at least two layers of roofing material on this building and there could easily be more.

Given the age of the roof, re-roofing will be needed in the not-too-distant future. Additional life can be obtained with careful maintenance which involves patching the roof surface as needed and coating the roof surface with the fibers aluminum roof coating material.

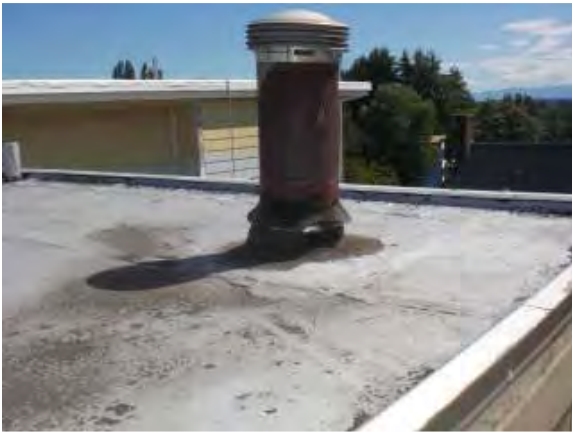
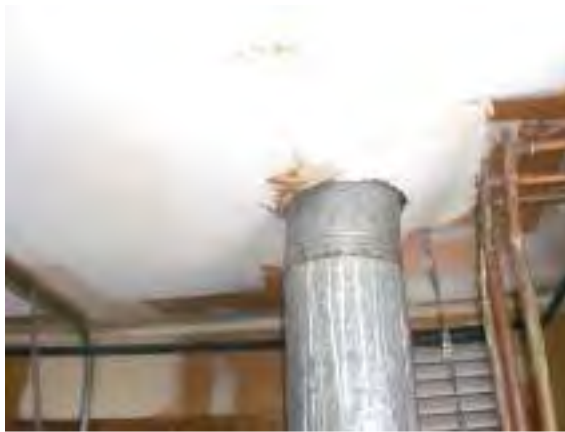
The metal exhaust flue for the boiler is corroding above the roof line in the top section should be removed and replaced now.

Previous water seepage has occurred around this exhaust flue into the mechanical room.

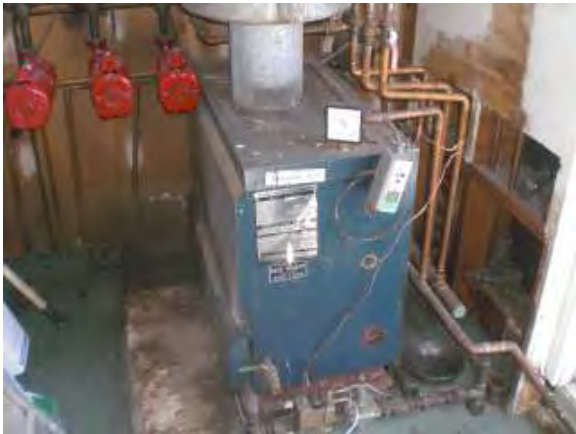
This building has a gas fired boiler located in the mechanical room on top of the roof. This boiler heats and circulates water to the individual radiators located through the interior rooms of the building.

The original boiler is still in use. However, this system was shut down at the time the inspection so could not be directly tested. Given the age of this boiler, replacement could be needed at any time.

At a minimum, this system should be fully inspected and serviced. Ideally, the heat would be turned on so it can be confirmed that heat flows fully to all individual radiators. Often, air becomes trapped in the system, which prevents full hot water flow. This can easily be remedied by bleeding the trapped air out of the radiators.

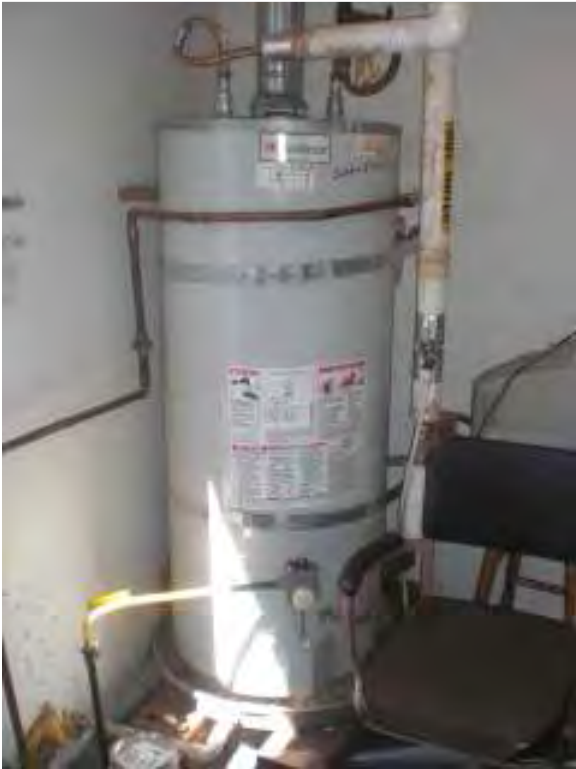
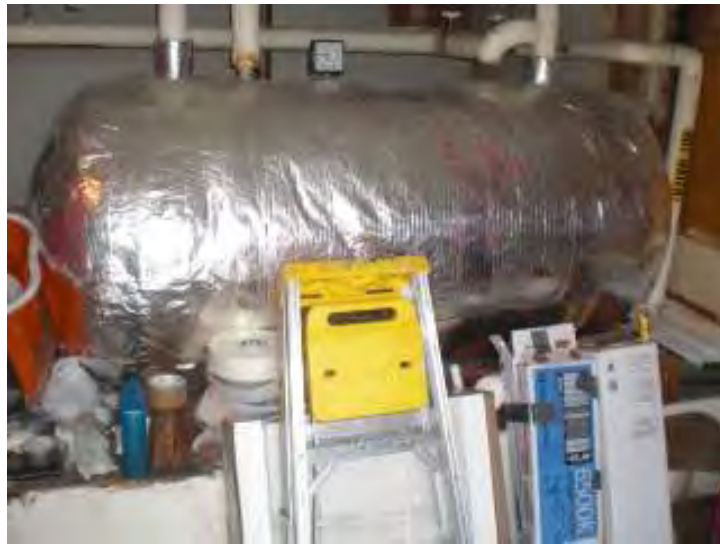
Where visible, this building is plumbed with copper water lines. Given the age of the building, it is possible that some galvanized water lines are still in use. It is common for galvanized piping to corrode over time and some sections may need replacing in the future.

No main water shut off valve was found. The owners or occupants should be asked as to the location of the main water shut off valve. If no shutoff valve is found, the water will most likely need to be turned off at the meter which is next to the street.

The gas-fired water tank is leased and owned by the gas company. This hot water tank was installed in 2007. This 75 gallon hot water tank feeds a larger separate storage tank so that there is adequate hot water available for the needs of the building.

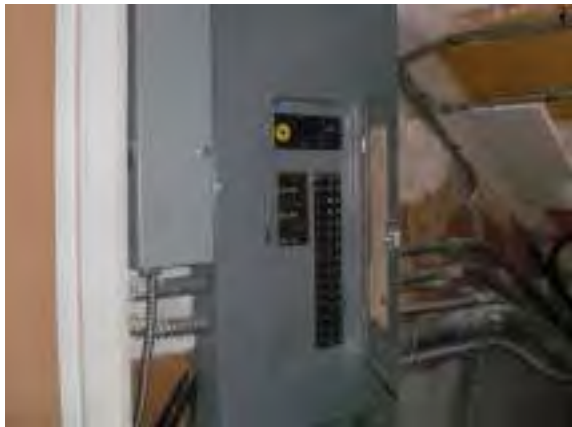
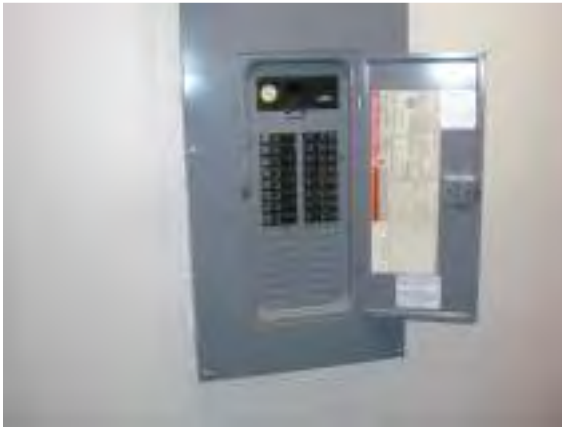
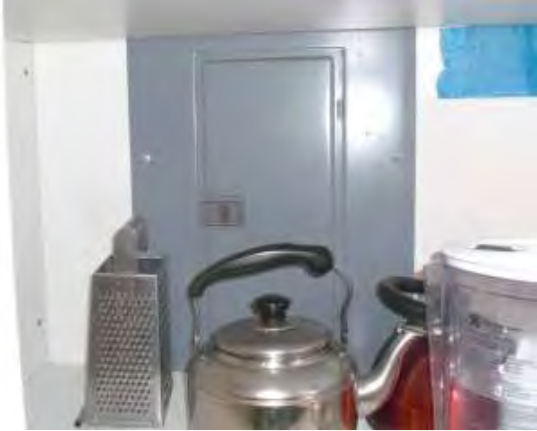
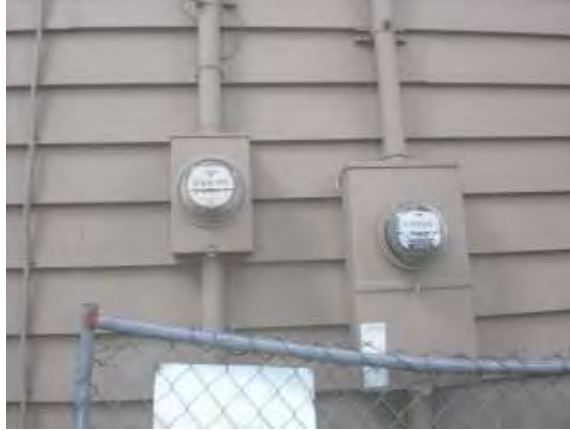
The main circuit breaker panels are located on the basement level. There is an additional circuit breaker sub-panel located in the kitchen.

These particular circuit breaker panels are high-quality and are manufactured by Square D. Interiors of the circuit breaker panels were not directly inspected.

Ground fault circuit interrupter protection was noted in the bathrooms and kitchens.
