# Metcalf Building Consultants Inc

## Inspection Report

**Client:** Susan Chesterfield / Barb Ives **Date:** 7-7-17 **Doc. #** 16911  
**Inspection Location:** 909/911 N 130th Ave Seattle Washington **Building Type:** One story  
**Crawl space** X **Weather:** partial clear **Time of day:** 11 AM

**Inspection Location:** 913 N 130th Ave / 914 N 128<sup>th</sup> Ave Seattle Washington

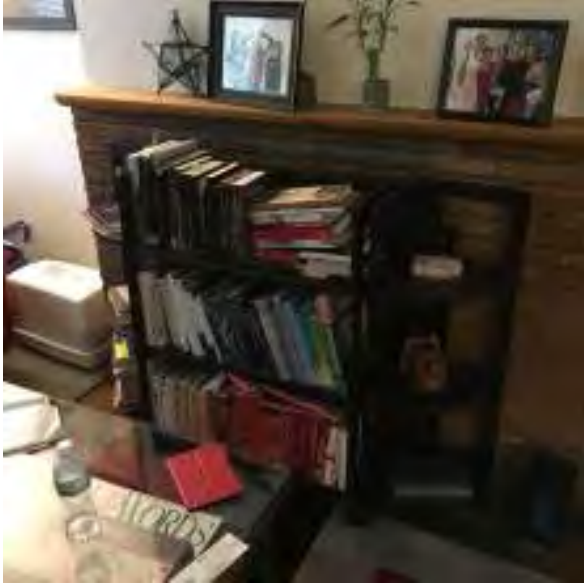
The fireplace in 909 is in generally good condition but the damper is no longer functional so this is a source of heat loss. It is recommended that either glass doors be installed or a new Damper be installed on top of the chimney flue openings.

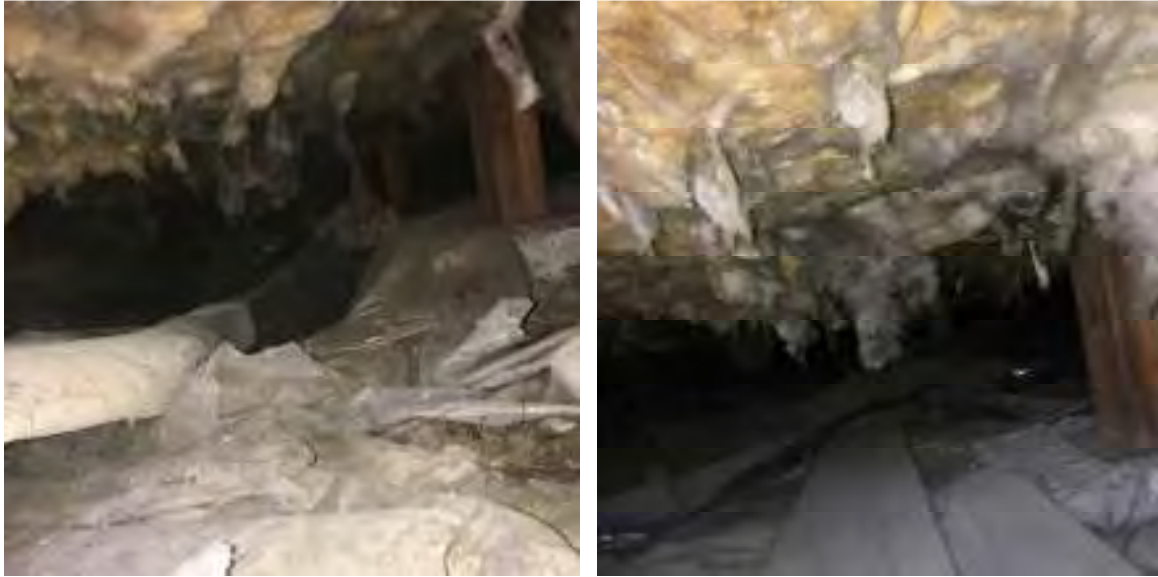
There is insufficient clearance between the earth in some sections the crawl space and the framing members. There should be at least 18" clearance between the earth and all wood floor framing and at least 12" clearance between the earth and all beams or girders. This lack of clearance prevented a full inspection.

The crawlspace was dry at the time of inspection. See NOTE below. Due to the dry conditions, although a full inspection of this area could not be done, it is not suspected that any significant detrimental conditions will be found.

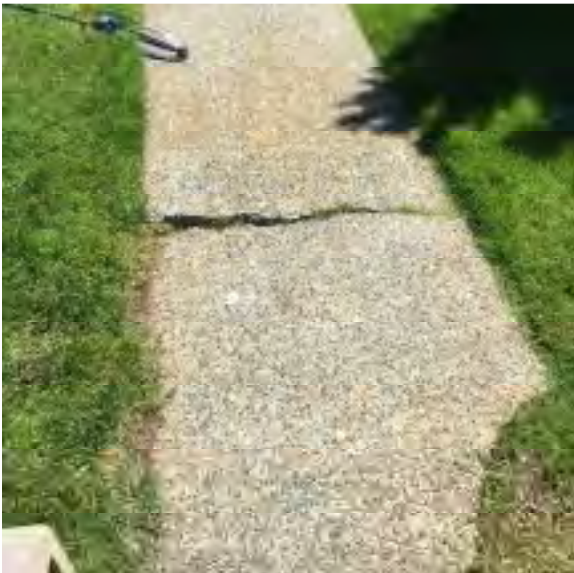
The general condition of the building site is good and has been well maintained.  
There is a normal settling crack in the front walkway that is a minor tripping hazard.

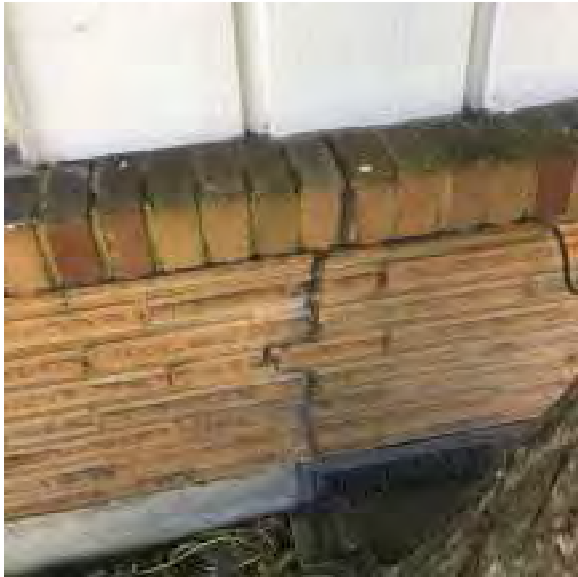
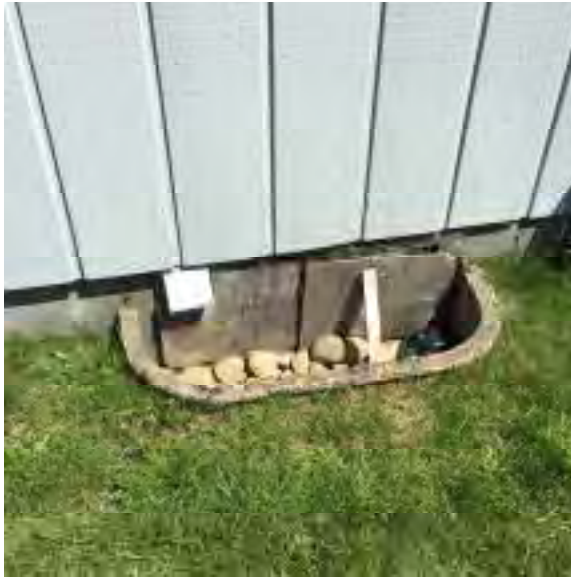
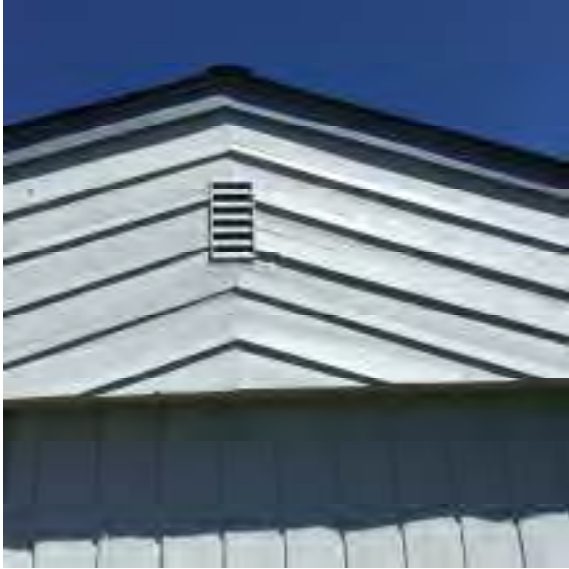
The brick veneer siding is in good condition with no indications of any significant settlement or displacement occurring. There is a small crack in the front brick work of this building which most likely occurred during a previous earthquake. This cracking does not constitute a structural problem.

The cedar siding is also in good condition. Some of the south siding is warping and is a little bit weatherbeaten which is common to find. No rot is occurring here. As maintenance, all siding should be kept securely nailed to the building and all siding/trim intersections should be kept well sealed with caulk.

The crawlspace access cover is deteriorating and should be removed and replaced with treated lumber that will not deteriorate.

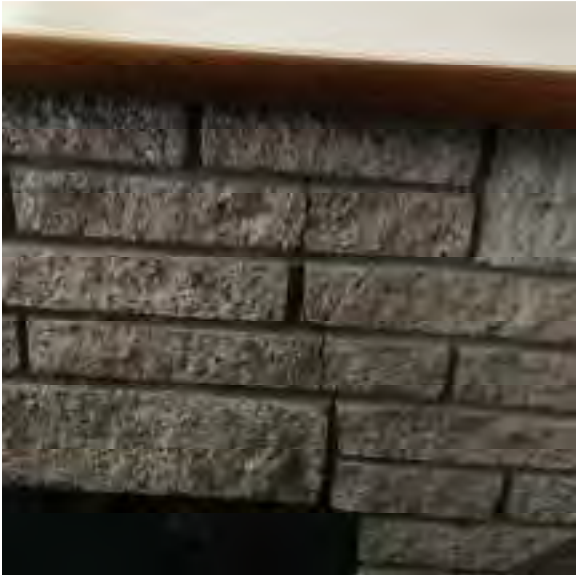
There is a small settlement crack in the front brick work of the fireplace in 914 that does not constitute a structural problem.
