Metcalfe Building Consultants Inc

Inspection Report

Client: Michael Mortenson Date: 9-11-17 Doc. # 16967

Inspection Location: 2315 E Ward St Seattle Washington Building Type: Two story

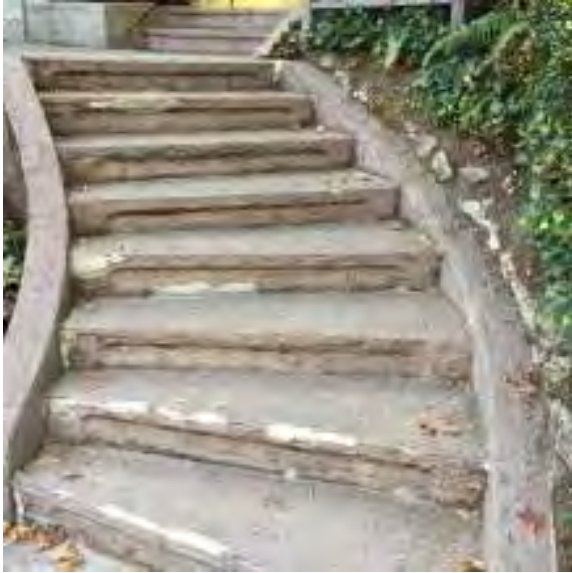
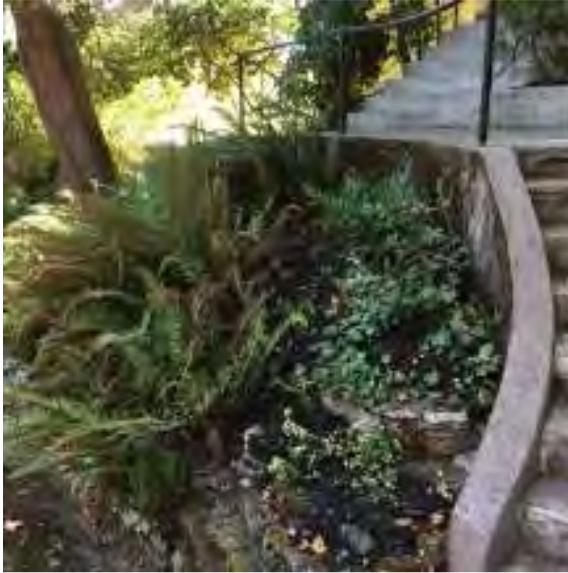
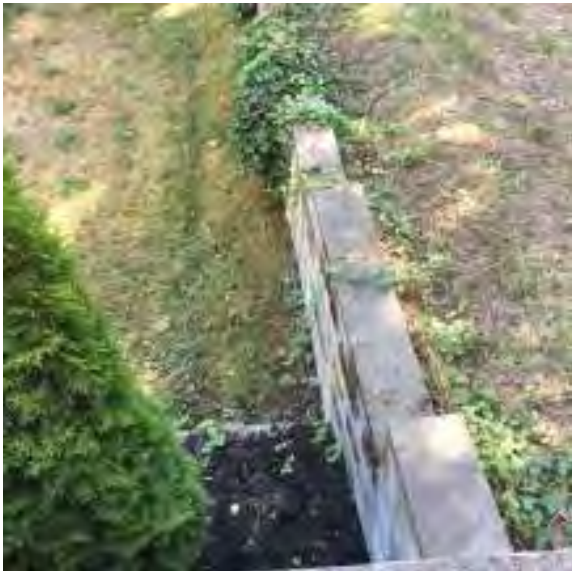
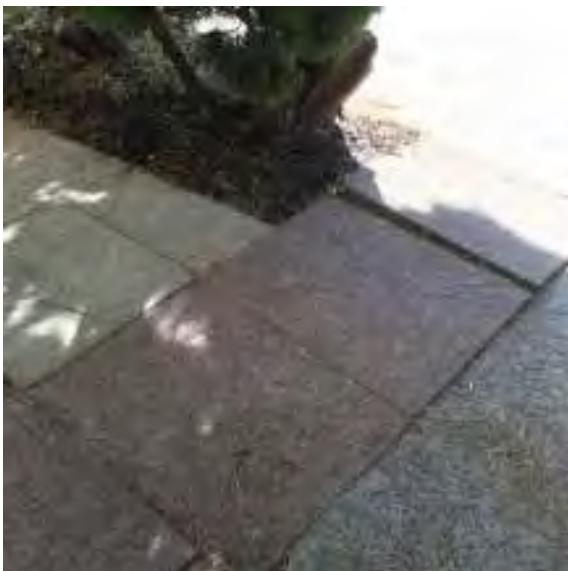
Installing handrails on the front stairs is recommended. Current code requires all decks, stairs and porches to have railings at least 30" high and vertical or horizontal rail members no farther apart than 4" for safety purposes.

There are normal settling cracks in the back walkways. There are a few small ledges due to tree root growth.

The back hollow block concrete retaining wall is leaning slightly. Most likely, it will remain in this position indefinitely but could need repair in the future.

Erosion should be prevented from occurring from the slope section on the front of the building site. This is a landscaping concern only, not a soil stability concern.

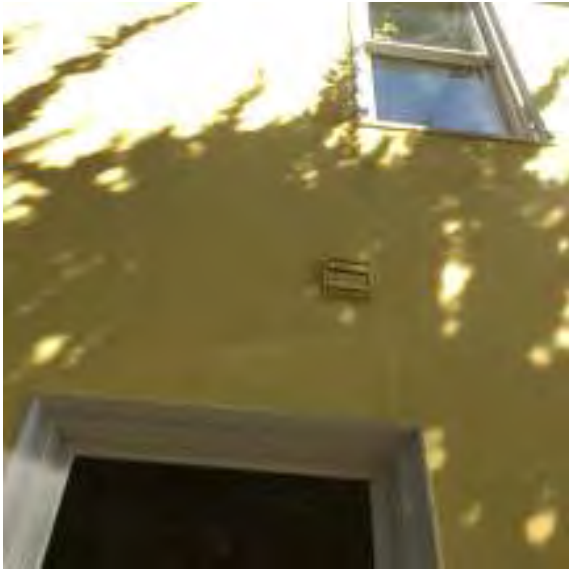
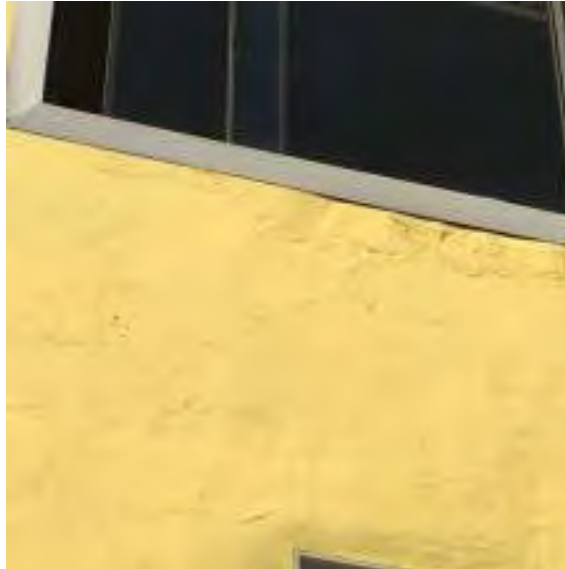
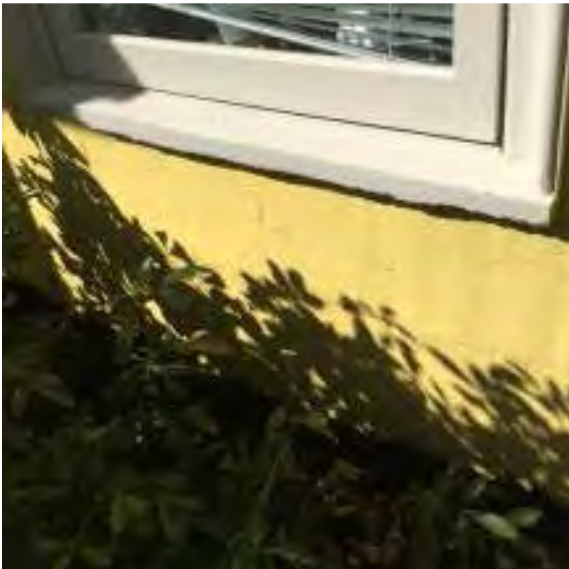
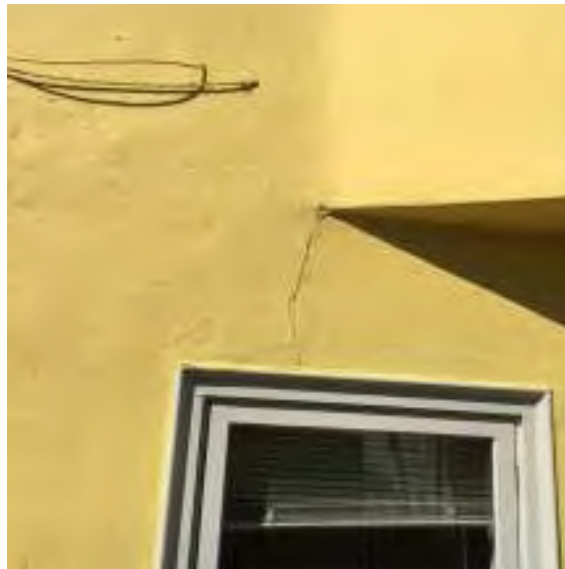
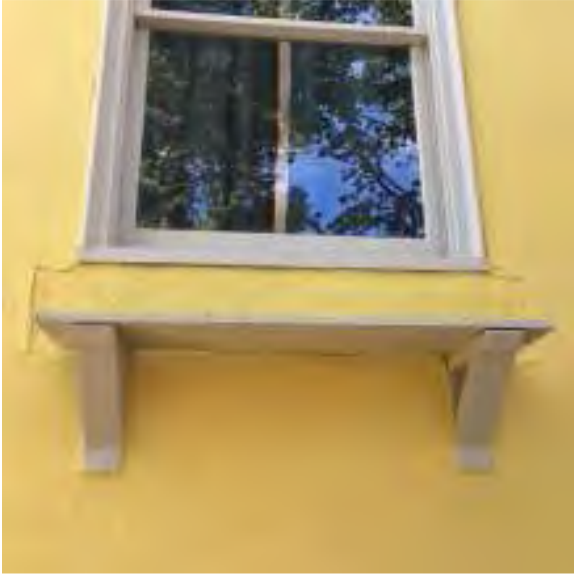
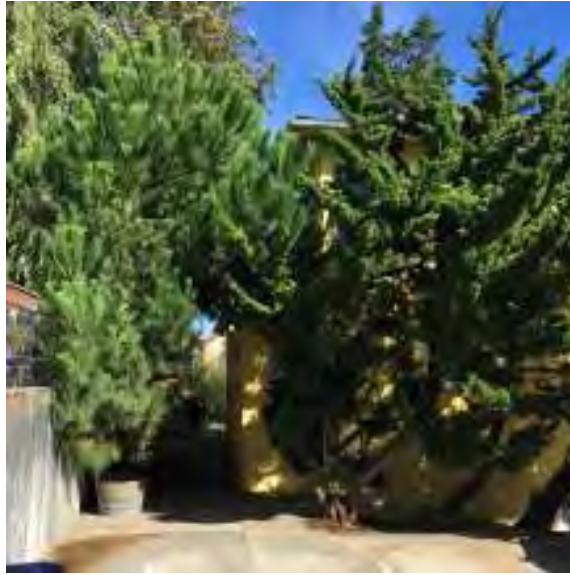
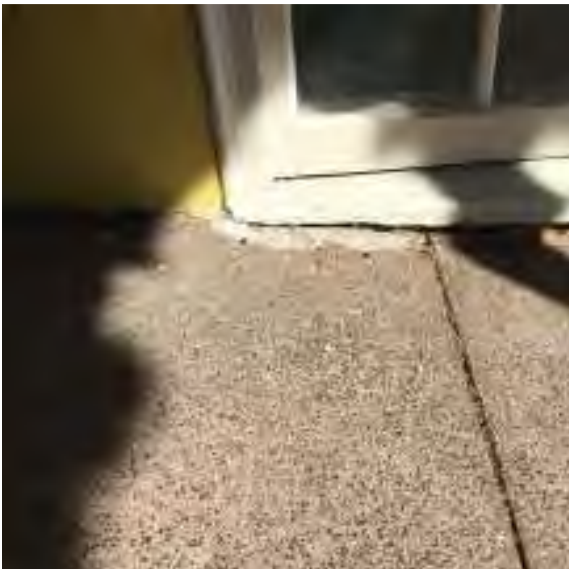
Majority of the stucco appears to be in good condition for its age. Evidence of cracking is present on the exterior of the building. None of this cracking appears to be abnormal or excessive. Some sections have been patched.

There is a minor amount of rot occurring to one of the back basement window sills. All damaged wood should be removed and replaced with new wood.

All trees and foliage should be kept cut back away from contacting the building.

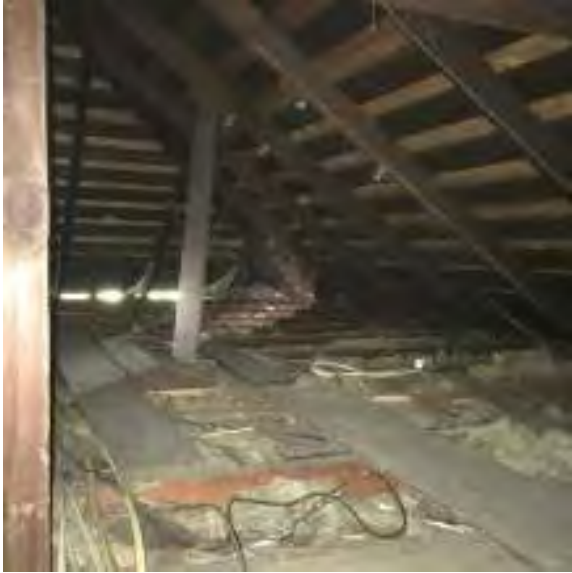
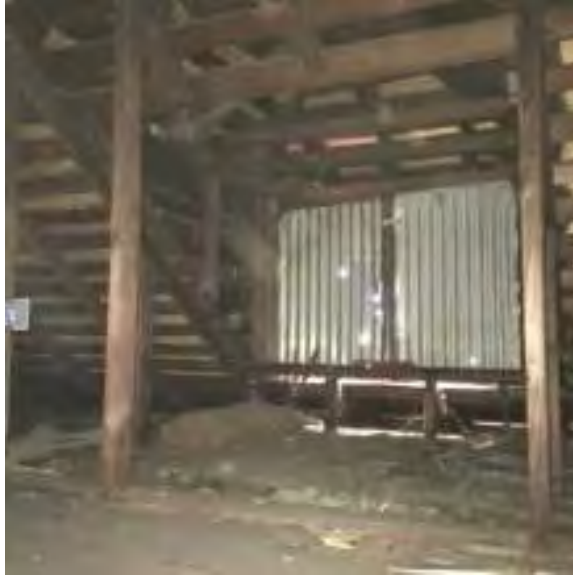
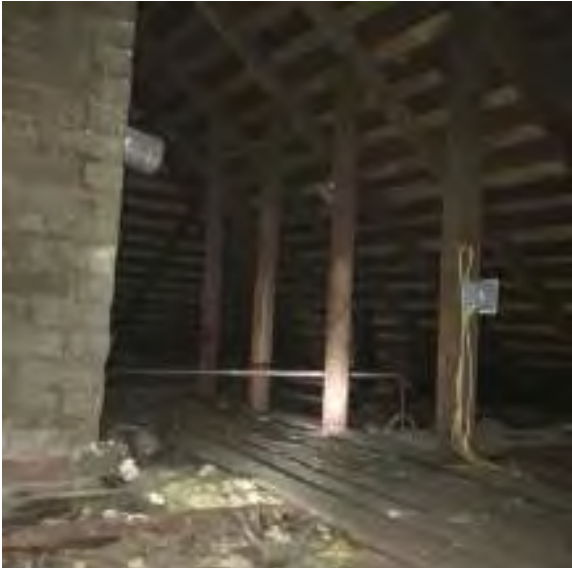
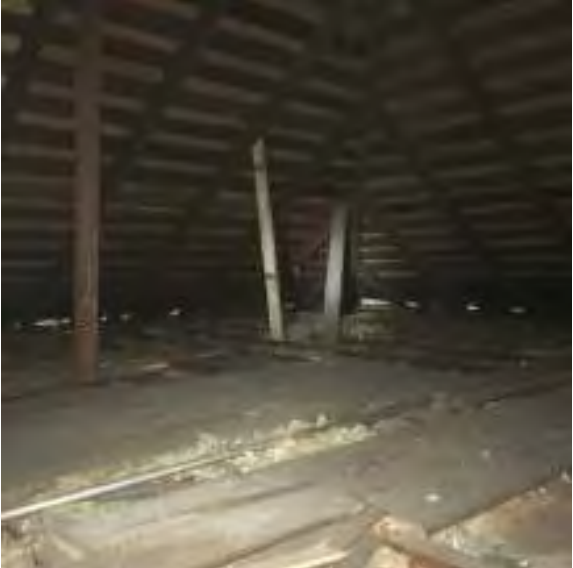
The amount of insulation in the attic space is considered minimal by today's standards. It is recommended that more insulation be installed in this attic space. See NOTE below.

There are gaps underneath the roof edges that are not screened. While these openings are helpful for ventilation, birds and insects can enter the building. Installing screening here is recommended.

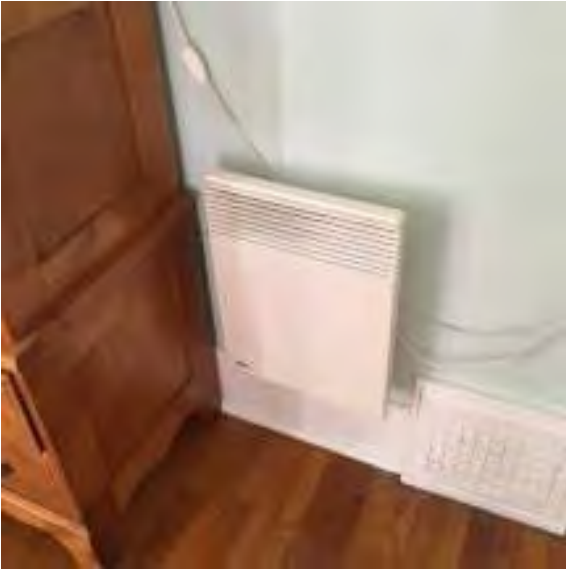
Newer high quality electric wall mount heaters have been installed in all of the apartments. These heaters are in good condition and are sufficient for the heating needs of the individual apartments. Carbon monoxide alarms are present in all of the units.

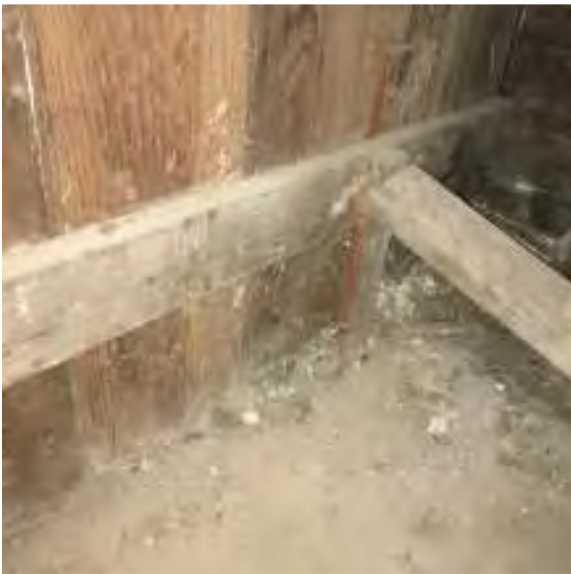
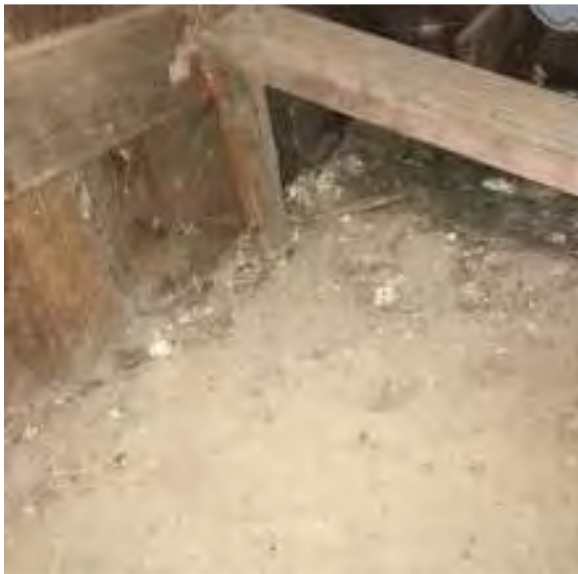
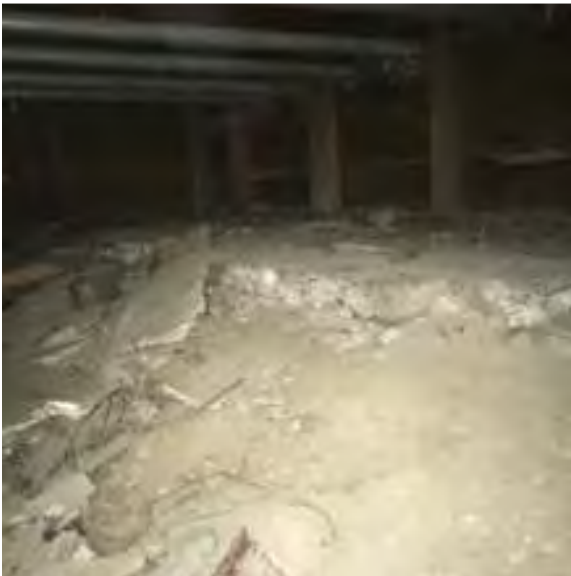
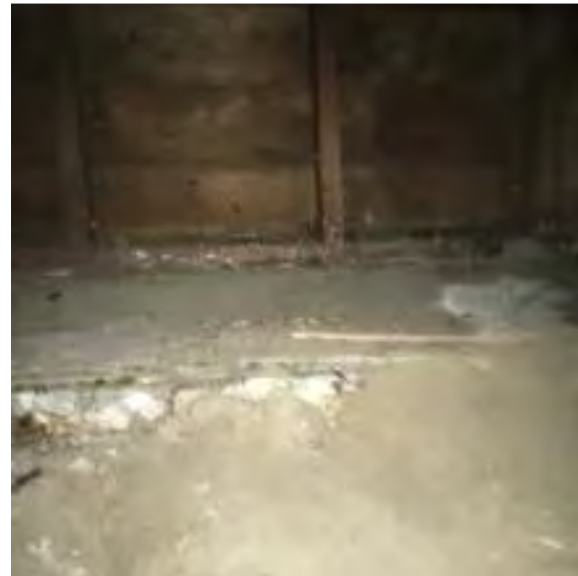
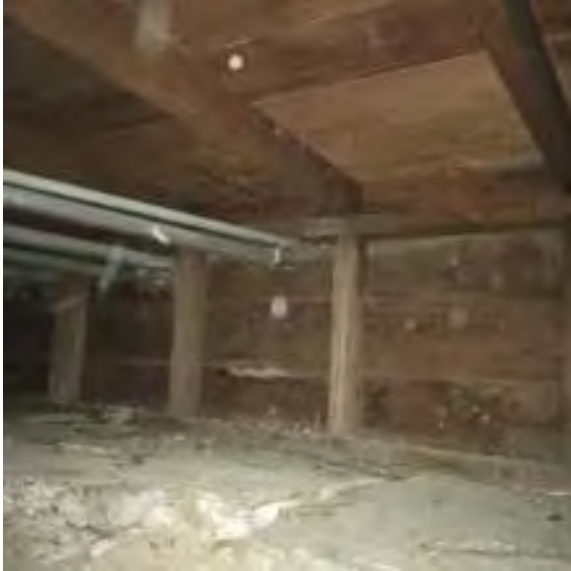
There is earth to wood contact to the wall material in the crawlspace underneath the front porch. All earth should be kept at least 6" below siding, trim and any other wood members unless the wood is treated wood rated for earth to wood contact. All damaged wood should be removed and replaced with new wood.

There appears to be a minor amount of damage to some of the lower wall sections in the back crawlspace. All damaged wood should be removed and replaced with new treated wood.

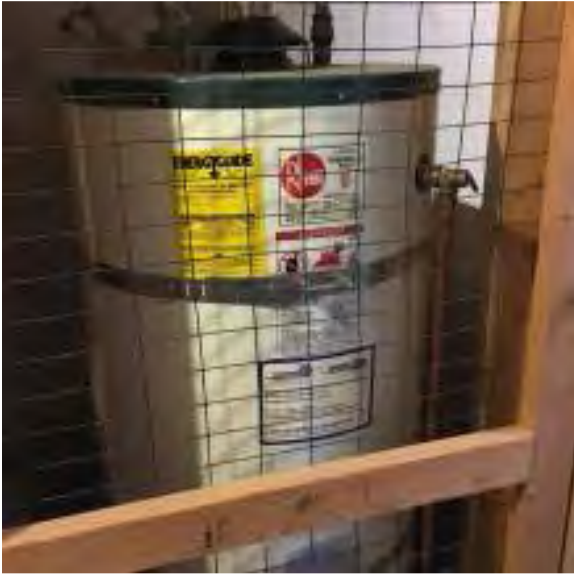
The hot water tank was installed in 2002. Most hot-water tanks have a 10 to 12 year life expectancy so replacement could be needed in the near future.

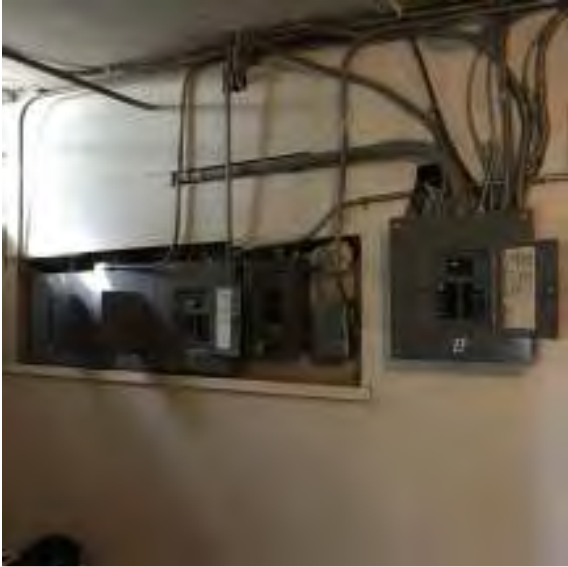
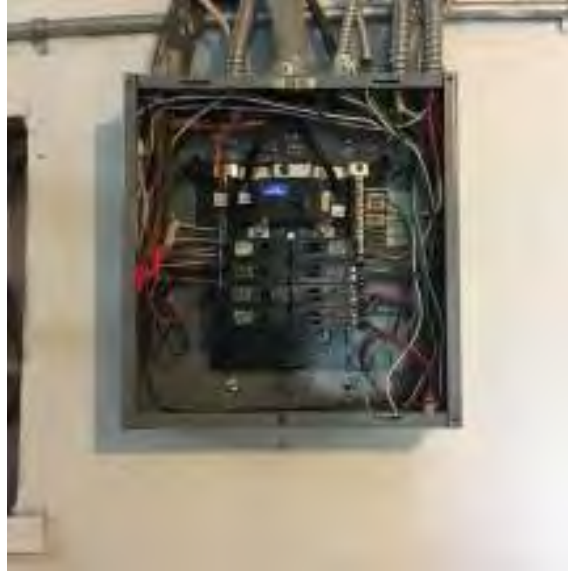
Newer good-quality circuit breaker panels have been installed. The interior of one of the circuit breaker panels was inspected as a representative sample.

Some of the older knob and tube wiring is still in use.
